### **SURVEILLANCE**

### AND INSPECTION REPORT

Client Name: Drapers Civil Contracting Pty Ltd Project Name: The Quay 2 Estate Stage 5B

Date: 24<sup>th</sup> of May 2018 Author: Mr. Sam Loza Reference No.: 1917-053

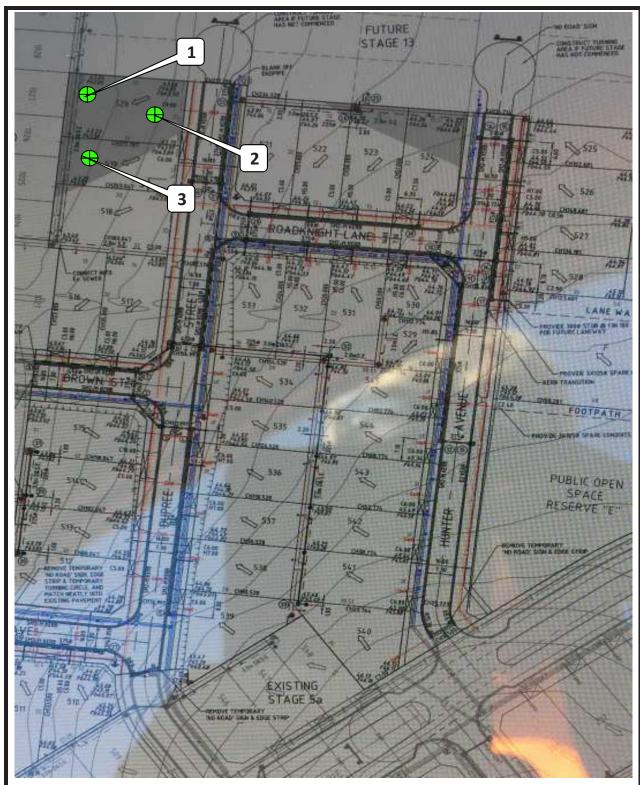
CLIENT: DRAPERS	DATE: 13/2/18	JOB No.: 1916/202
LOCATION: The Quay 2 Estate Stage 5B	OPERATOR: NM	CHECKED: EG
Sketch indicating compaction test locations	SCALE: NTS	FIGURE No: -

A total of three compaction tests were performed on the fill construction. Results are presented in Appendix B of this report.

Test results indicate that the above-mentioned requirements have been successfully achieved.
