LEVEL ONE

SURVEILLANCE

AND INSPECTION REPORT

Project Name: The Quay 2 Estate Stage 13

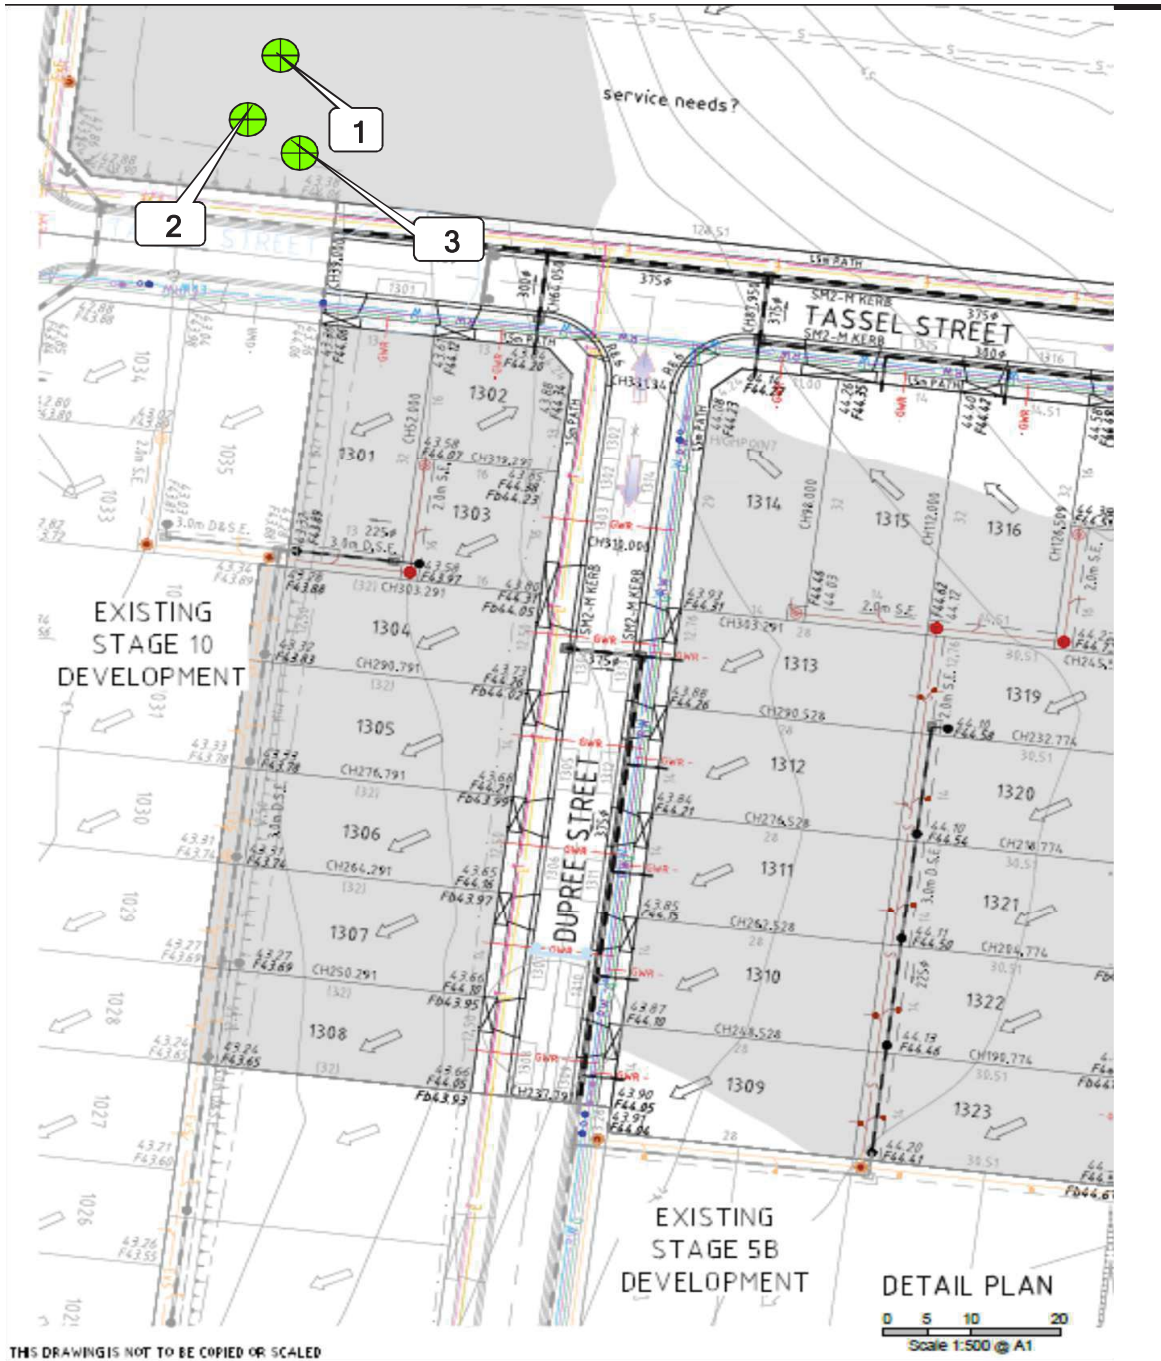
CLIENT: DRAPERS	DATE: 11/8/17	JOB No.: 1916/165
	LOCATION: The Quay 3 Estate Stage 13	OPERATOR: NM
Sketch indicating approx. compaction test locations	SCALE: NTS

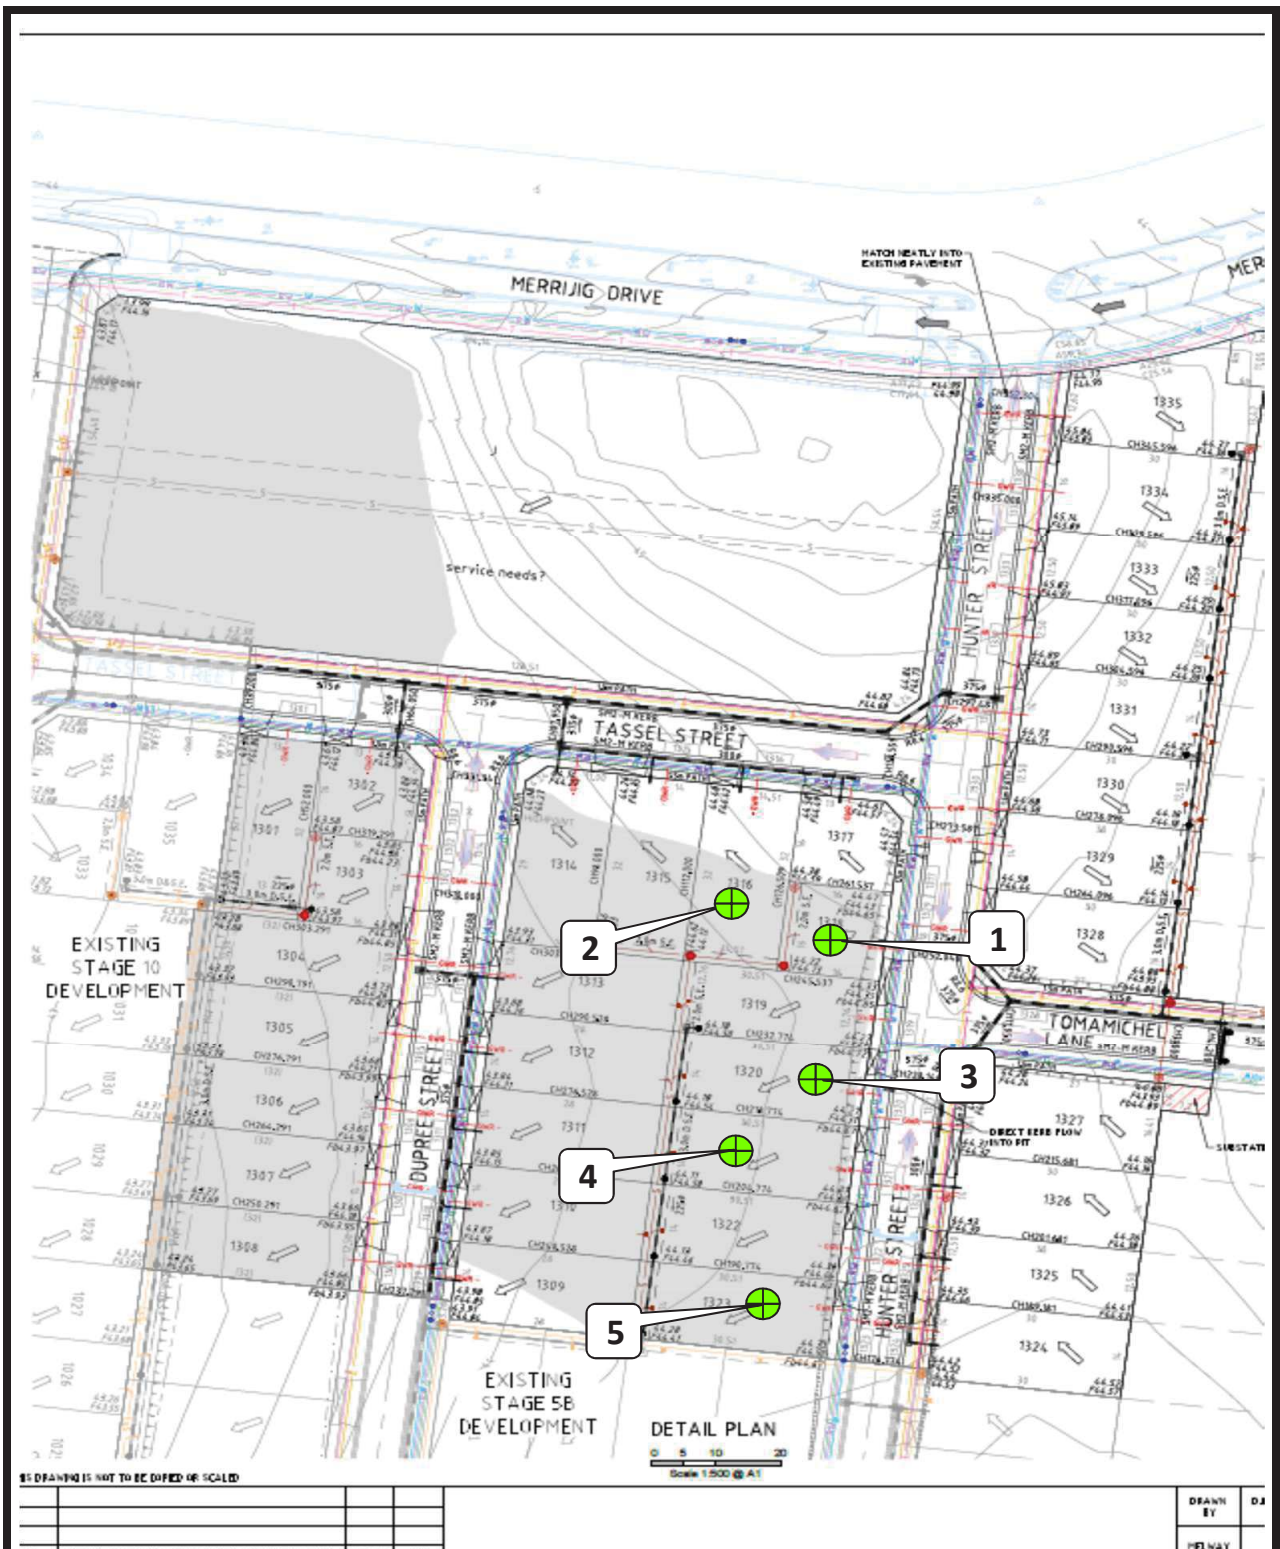
**Sketch indicating compaction test locations**

**DATE: 28/3/18**

**JOB No.: 1916/229**
