LEVEL ONE

SURVEILLANCE

AND INSPECTION REPORT

Project Name: The Quay 2 Estate Stage 9

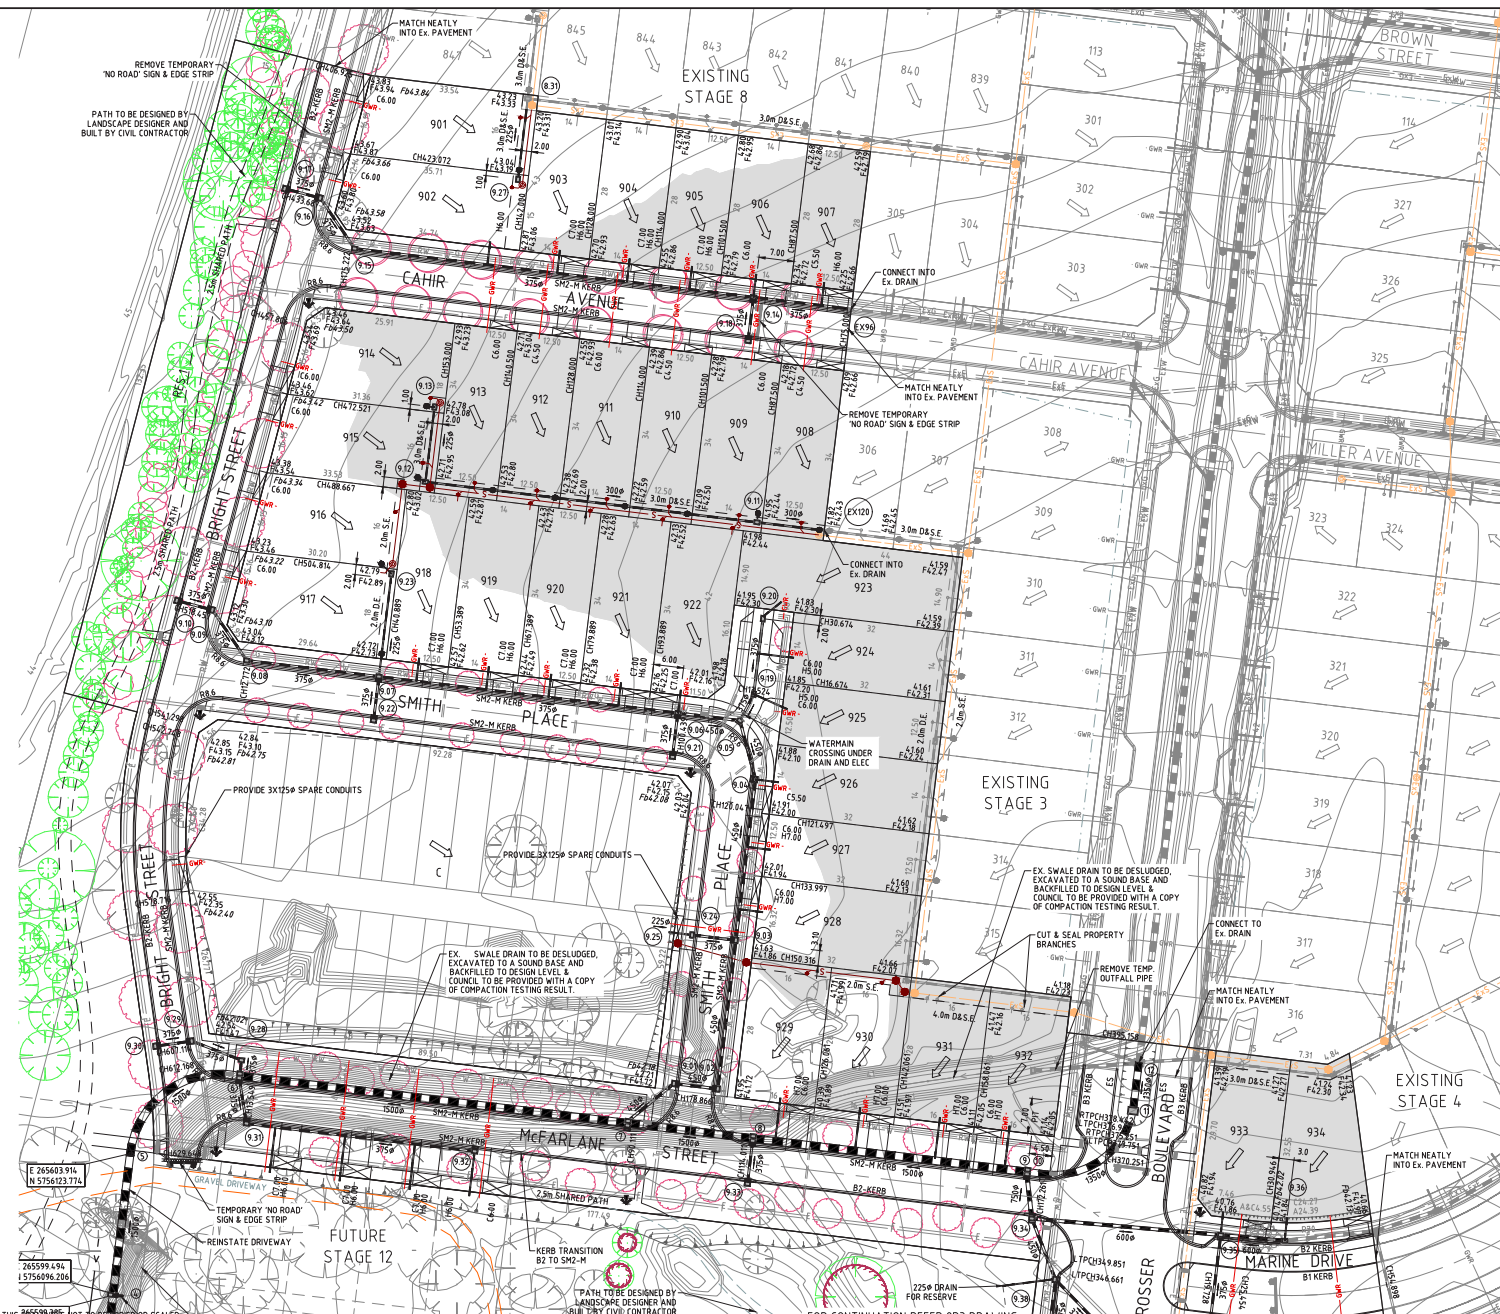
MULTI-PURPOSE PLACED DRAIN SETTING AND DRAINAGE PLAN - PR-2, REV-23.DWG

SURF COAST SHIRE	
THE QUAY 2 ESTATE	
STAGE 9	
LAYOUT PLAN - 1	
DRAWING No.	9R2
VERSION	C
REFERENCE	21437E/9
SHEET	2 OF 29
